Conditions Survey

The following report, the *Midtown Conditions Survey*, was completed in August 2005. The purpose of this work was to analyze conditions on all parcels located within the Midtown Study Area, generally located south of 17th Avenue, between Terry and Kimbark Streets, and north of Longs Peak Avenue (the “Study Area”), in order to determine whether factors contributing to blight are present and whether the Study Area is, therefore, eligible as an urban renewal area under the provisions of Colorado State Statutes. Establishment of an urban renewal area would allow the City of Longmont, through its urban renewal authority, to use designated powers to assist in the redevelopment of properties and improvements within its boundaries.

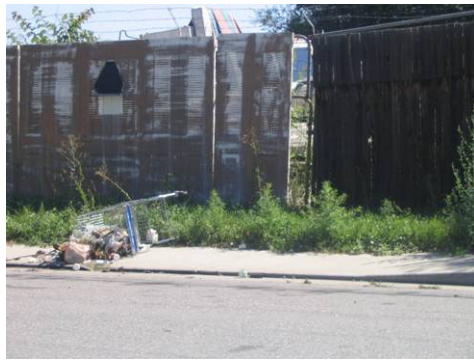
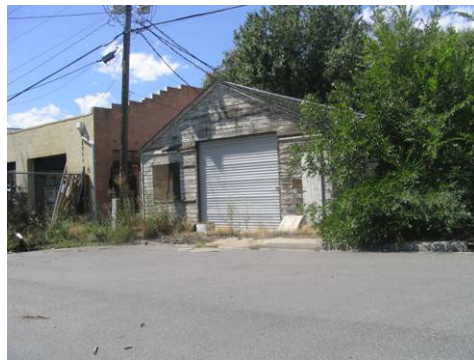
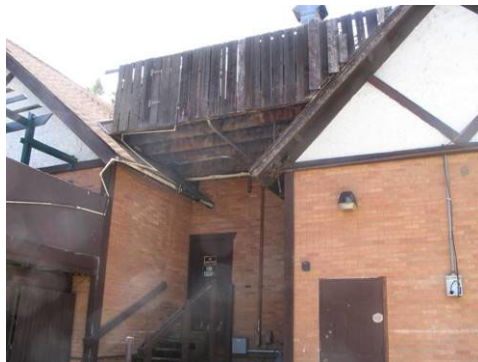
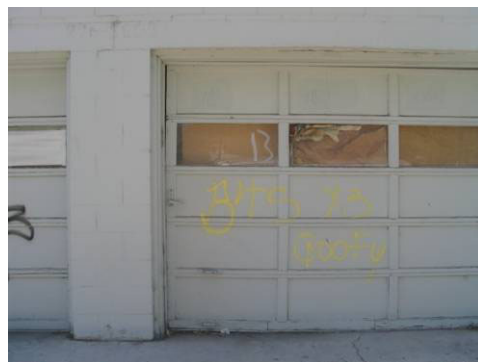
found within properties throughout the Study Area. The most common examples of structural deterioration found in the Study Area involved poorly maintained exterior finishes, and fascia and roof deterioration. Many properties were observed to have outbuildings in disrepair. Some older properties were also found to have window, roof, and wall deterioration. Other Study Area structural problems, though less common, include deterioration of exterior walls, gutters, fences, mechanical equipment and loading areas. Examples of properties affected by Condition (a) are shown in the photos below.

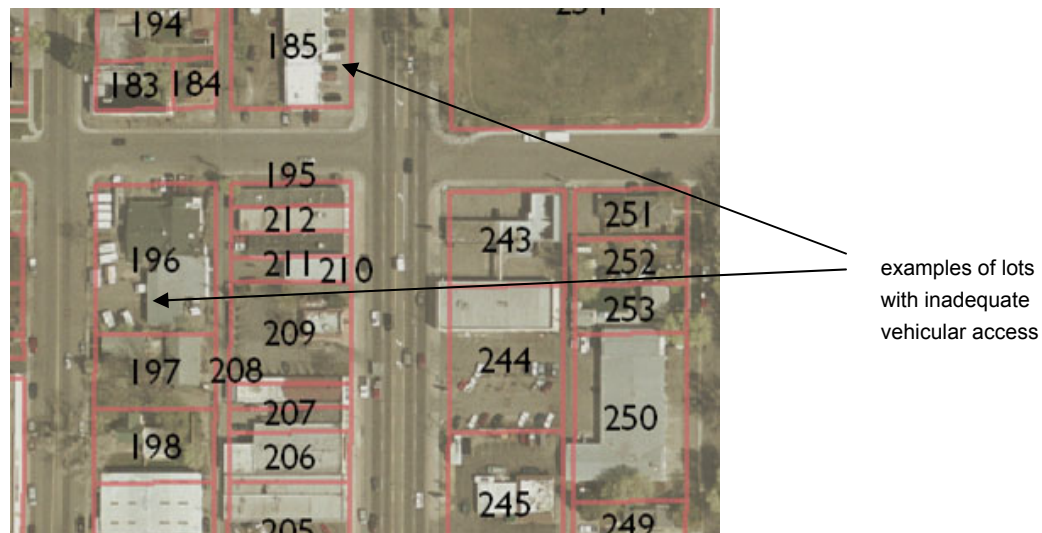
Examples of Condition (c)

As with “faulty street layout”, properties with awkward, dangerous, or inadequate access to and from public streets were considered to have faulty lot layout. There were 24 such properties within the Study Area – usually because of small side parking lots with narrow access points and poor internal circulation.

The aerial photograph presented below illustrates examples of faulty lots in the Study Area, as per the statute Condition (c).

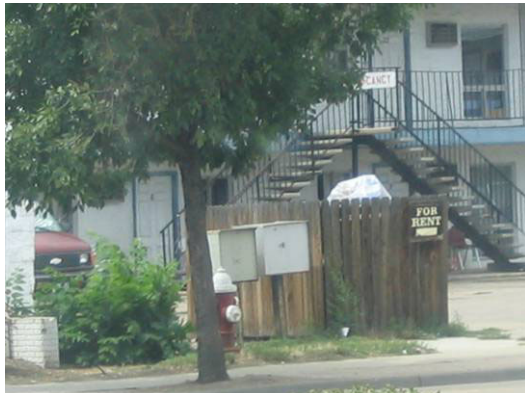
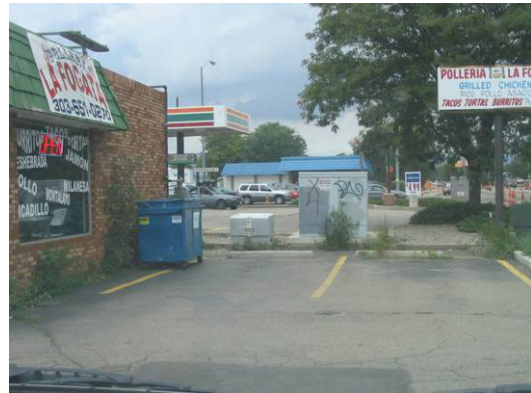
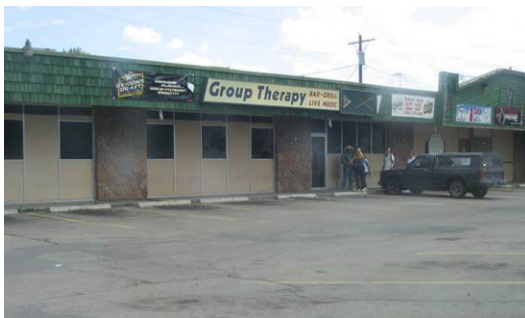
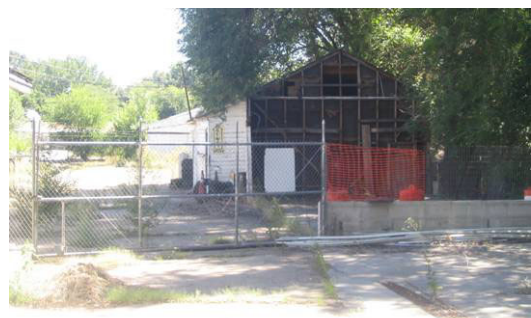
There are several locations within the Study Area exhibiting unsafe or unsanitary conditions. The most prevalent Study Area conditions considered unsafe or unsanitary include: poorly lit or unlit areas; unscreened trash or mechanical equipment; abandoned vehicles; and flood hazard.

Examples of parcels exhibiting condition (d) are shown below:

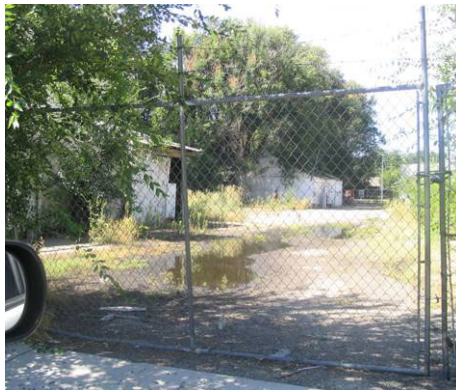
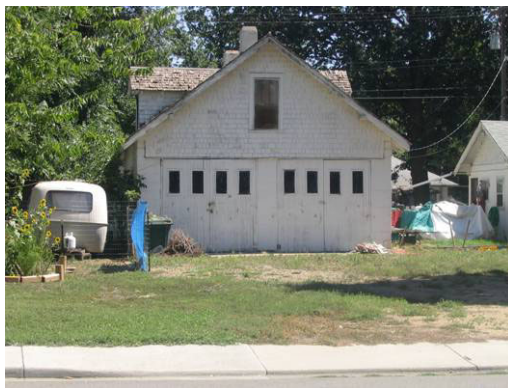
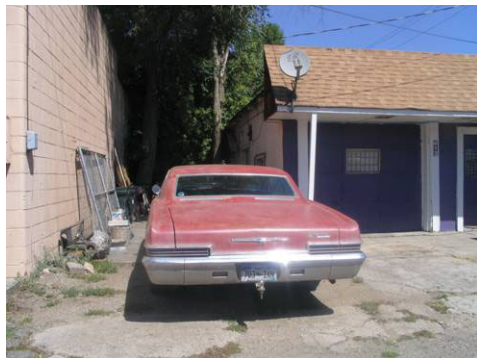
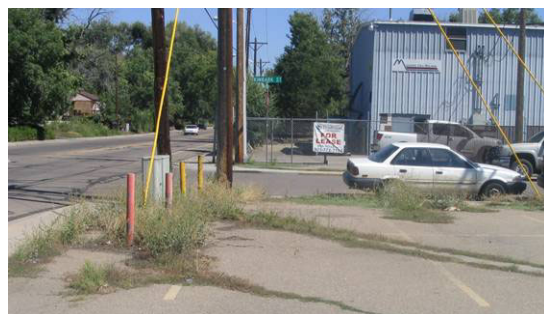
Examples of Condition (e)

A variety of blight conditions were observed within the Study Area related to the deterioration of the site and non-primary improvements. These conditions which negatively affect the appearance and utilization of the area, most commonly include parking surface deterioration, trash, weeds and general site neglect. Several sites were found to have site maintenance problems, a lack of landscaping, or signage problems. Although this condition was most prevalent in older properties, examples of site deterioration problems are found throughout the Study Area, as shown in the photographs below and detailed in the maps and field inventory.
